HOT SALT STRESS CORROSION STUDIES

R. L. Fowler and A. J. Luzietti
Pratt & Whitney Aircraft Group
United Technologies
West Palm Beach, Florida 33402

1 JUNE 1978

Final Technical Report for Period 1 April 1976 - 1 June 1978

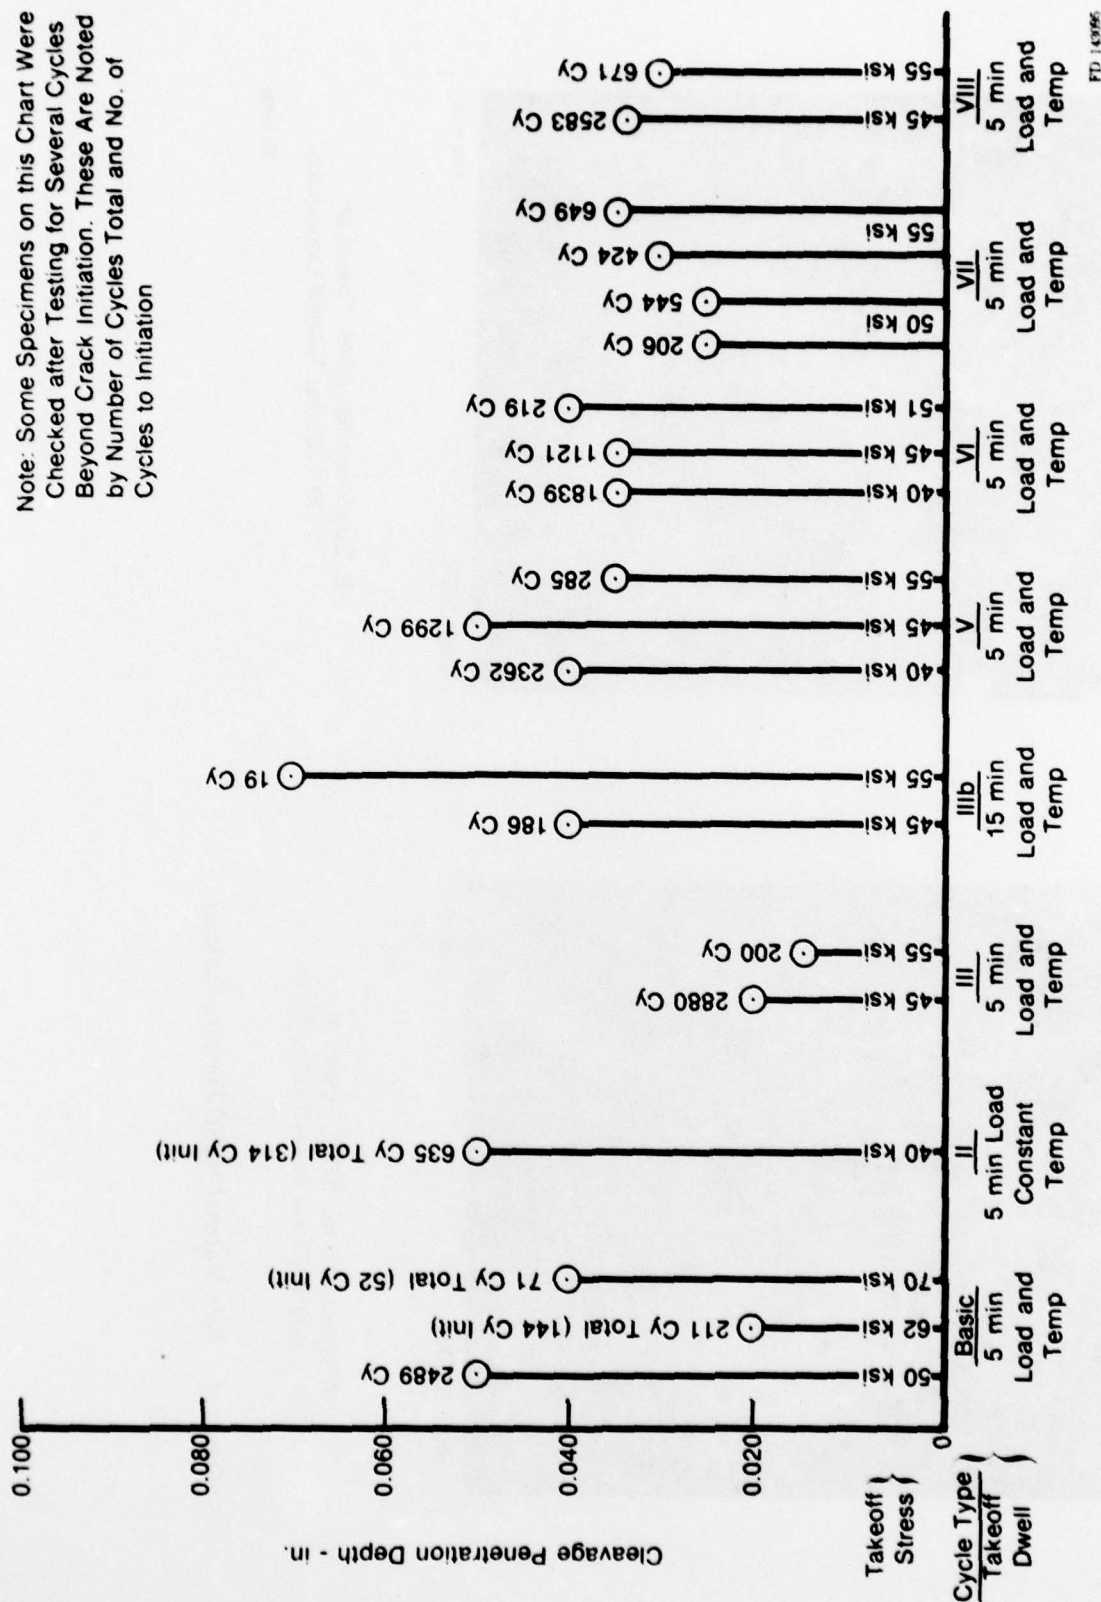
Note: Some Specimens on this Chart Were Checked after Testing for Several Cycles Beyond Crack Initiation. These Are Noted by Number of Cycles Total and No. of Cycles to Initiation

Figure 31. HSSC Crack Penetration Chart For Typical Phase I Ti-6-2-4-2 Bolthole Specimens

Typical HSSC damage penetration measurements for the various Phase I thermal-mechanical cycles tested are compared in Figure 31. The deepest corrosion penetration was observed on a high stress (55 ksi) Cycle IIIb extended dwell specimen, which also exhibited the lowest crack initiation life (19 cycles). Corrosion penetration for Cycle IIIb at lower stress was comparable to other cycles.

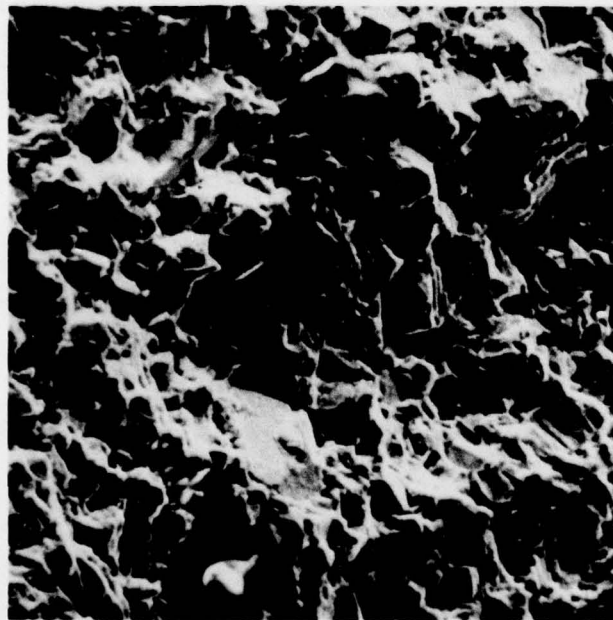
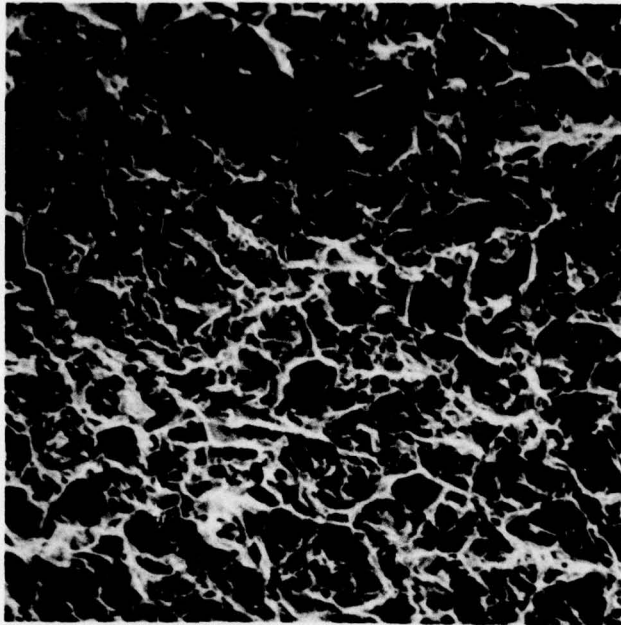
FD 14967

A. Appearance of Cleavage in HSSC Area

Figure 33. SEM Photographs of Fracture Features of Alpha-Beta Specimen No. 5776 Tested at 950°F/45 ksi Takeoff Conditions

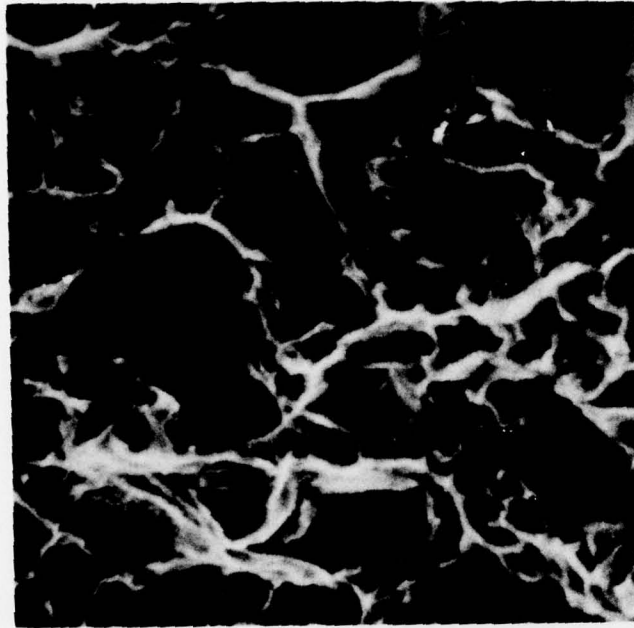
FD 143098

A. Appearance of Cleavage in HSSC Area

Figure 34. SEM Photographs of Fracture Features of Alpha-Beta Specimen No. 5776 Tested at 950°F/45 ksi Takeoff Conditions
